Report No. UT-10.16

LATERALLY LOADED PILE CAP CONNECTIONS

Utah Department of Transportation Research
Division

Brigham Young University
Department of Civil & Environmental
Engineering

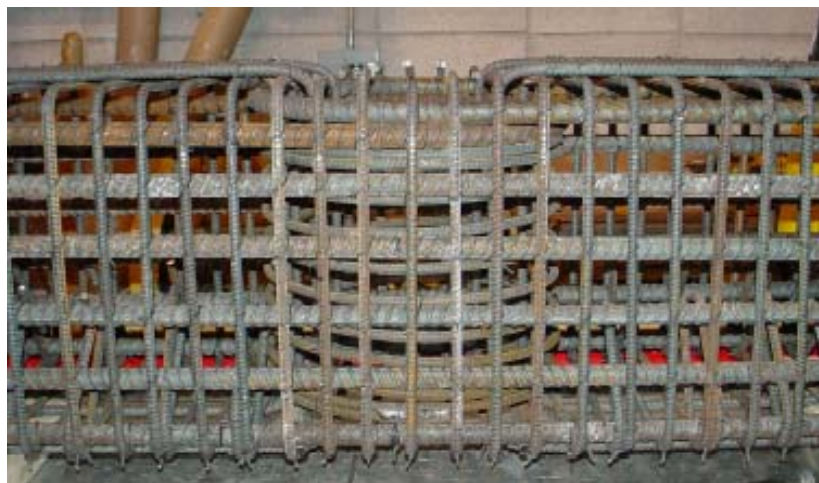
Figure 2-4 Reinforcing cage for pile cap Model 4 Montana State University (Stephens and McKittrick, 2005).

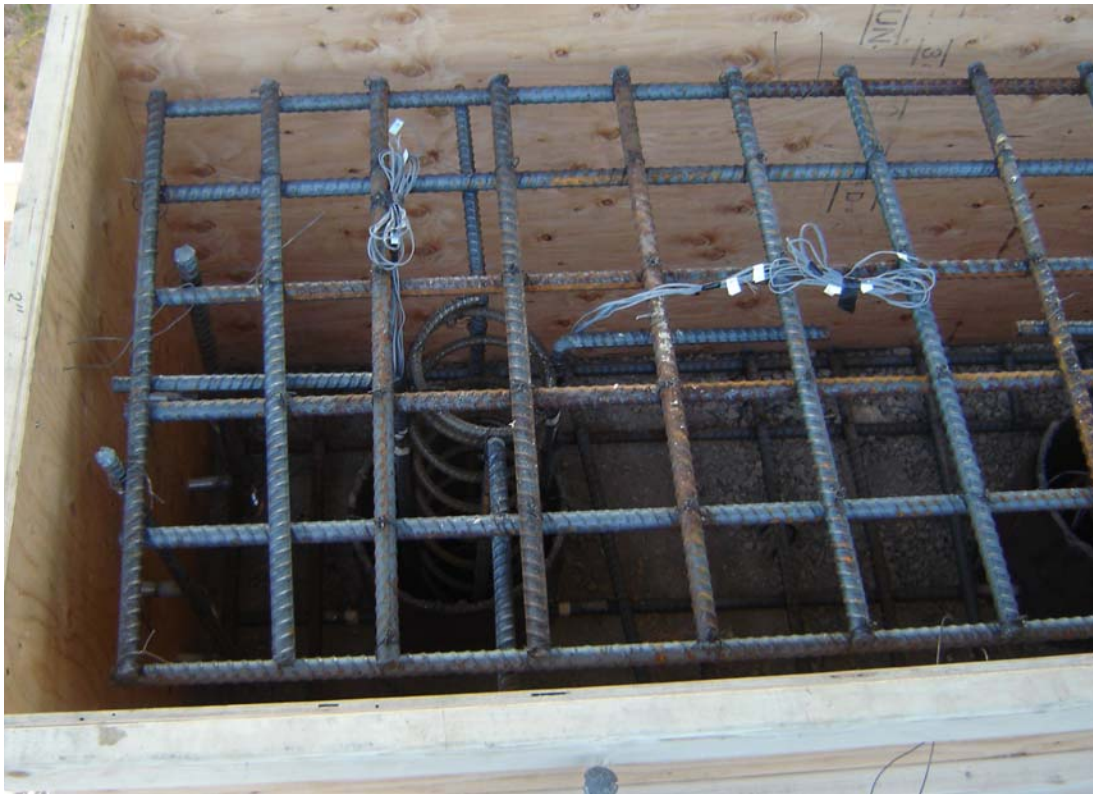
Figure 3-14 Photograph of Pile Cap 1 reinforcing.

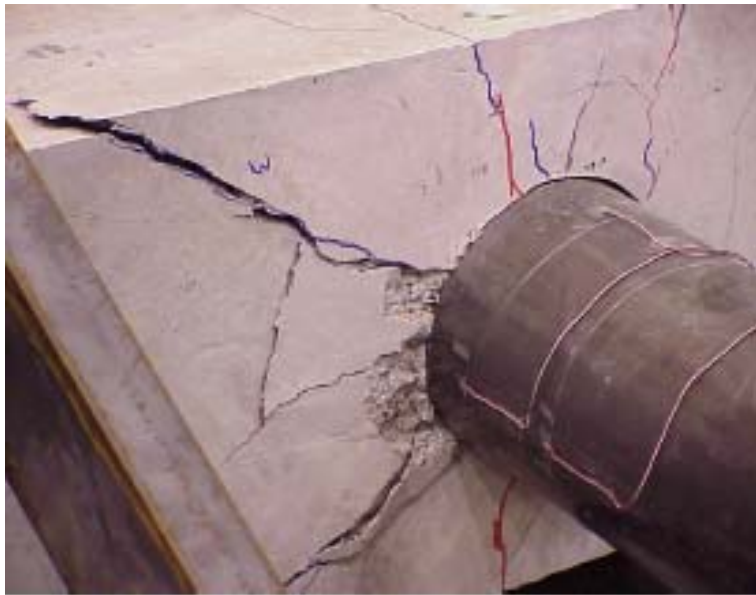
Figure 4-2 Failure of pile caps tested at Montana State University.

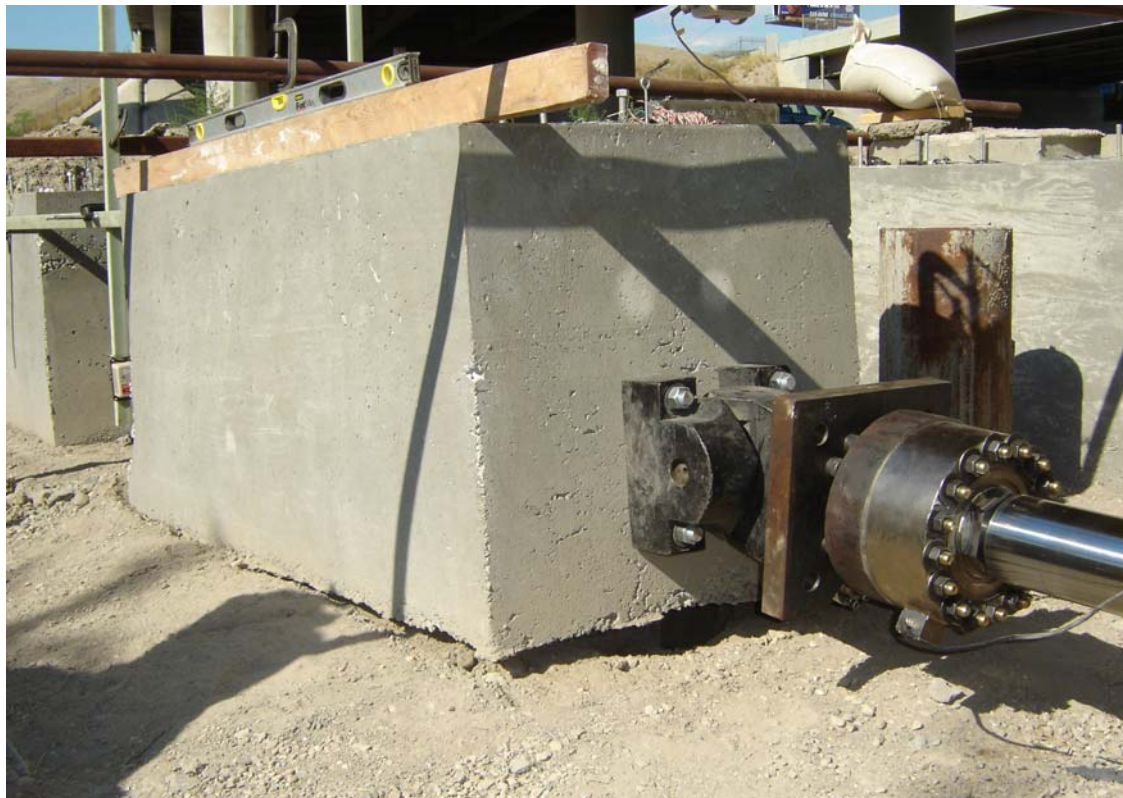
Figure 5-7 Photograph of Pile Cap 1 at failure showing uplift of the back pile.

the pile cap failure was considered to fall under the category of excessive deflection under load. This was due to the piles pulling out of the ground as shown in the photograph in Figure 5-7.

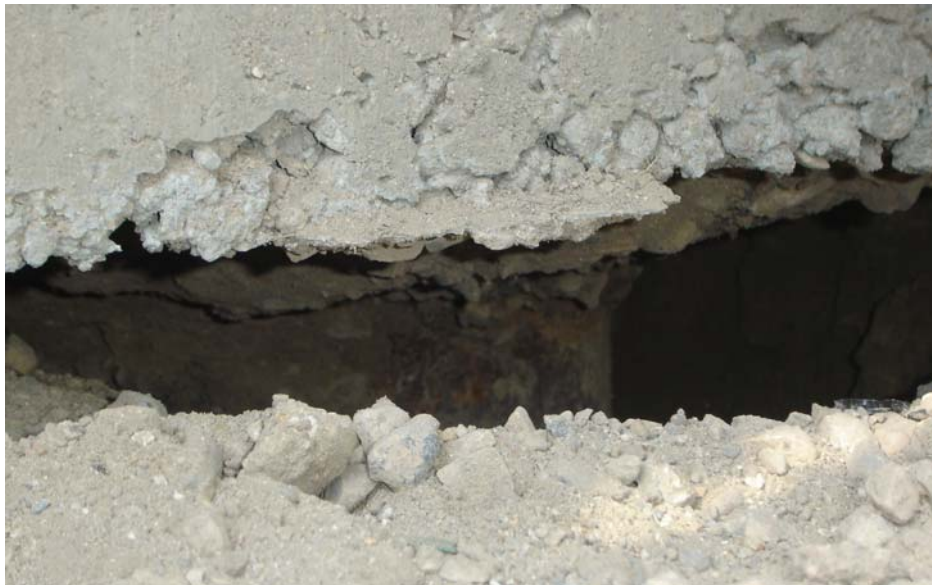
Figure 5-11 Pile Cap 2 failure in pullout.

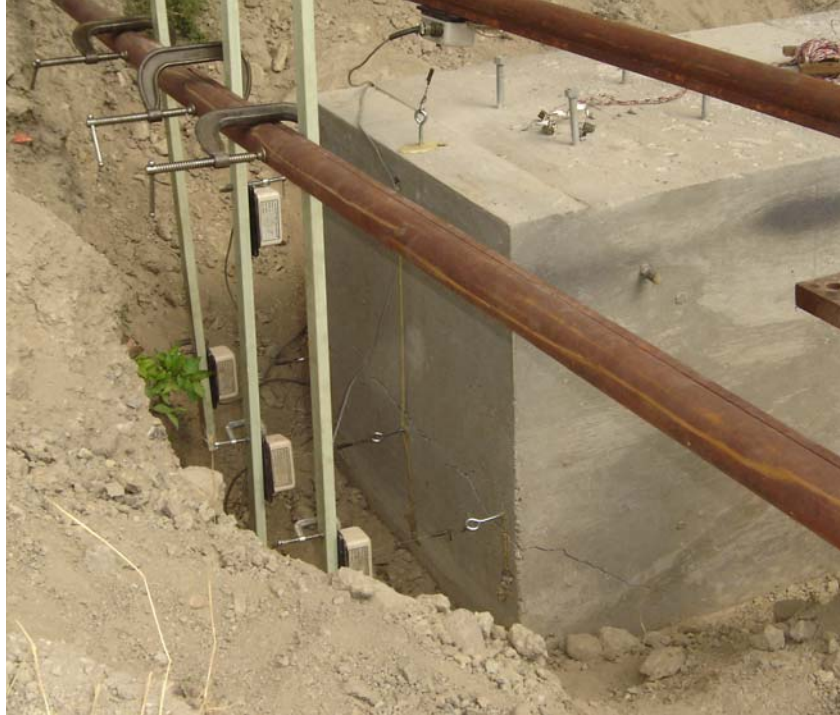
Figure 5-12 Initial cracking on the front face and side of Pile Cap

surprisingly similar to that for the other tests. With the excessive amount of cracking it appeared that the back pile did little in resisting deflection, yet either the front pile compensated or the remaining concrete was sufficient to transfer load between the two piles. The cracking occurred at the location

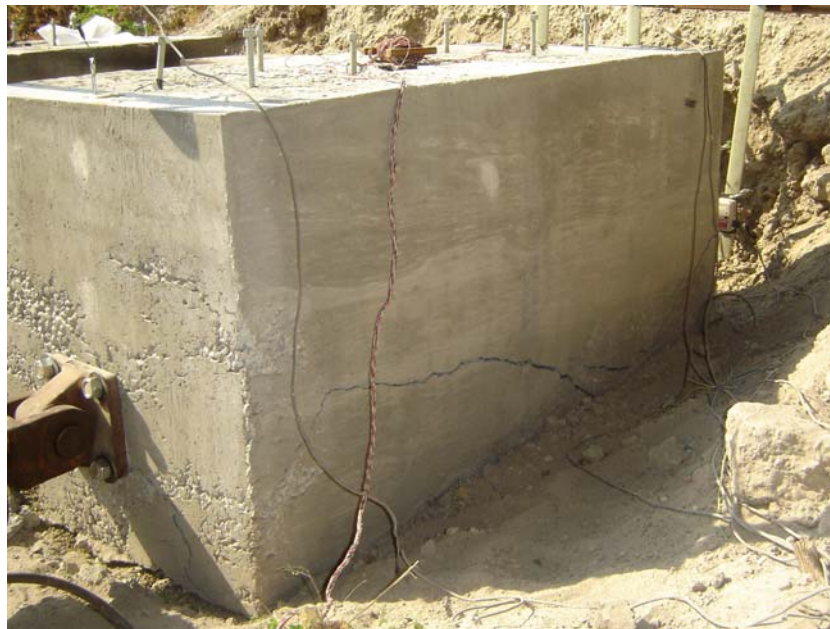
Figure 5-13 Cracking at a 90 kip load on the back and side of Pile Cap 3.

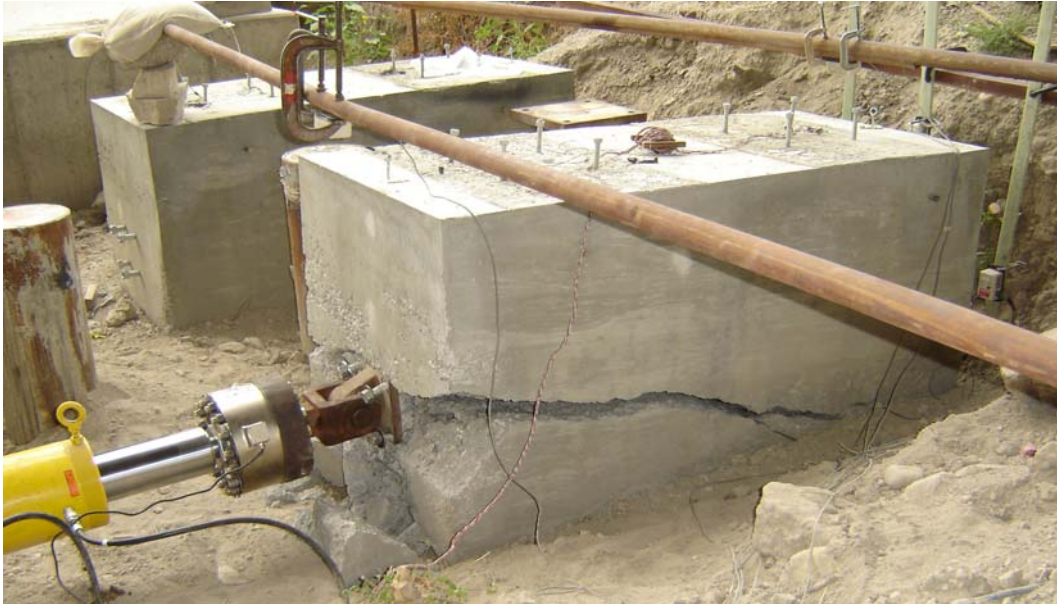
Figure 5-14 Shear crack in Pile Cap 3 at failure.

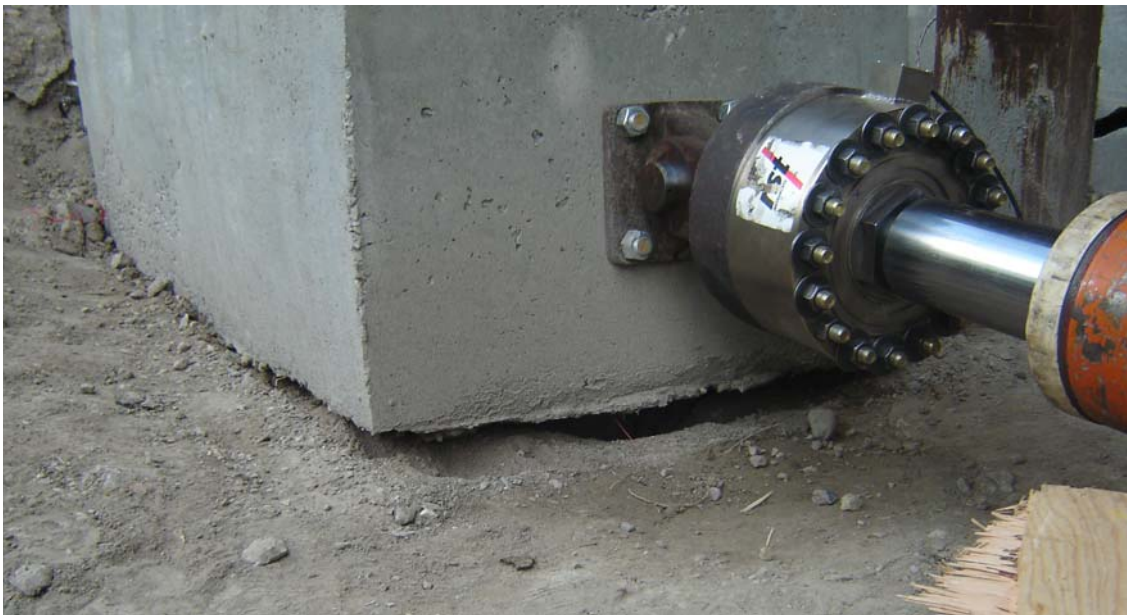
Figure 5-18 Photograph of Pile Cap 4 after pullout failure.
