Report No. UT-13.09

## **PHYSICAL AND CHEMICAL EFFECTS OF DEICERS ON CONCRETE PAVEMENT: LITERATURE REVIEW**

Utah Department of Transportation  
Research Division

Brigham Young University  
Department of Civil and Environmental  
Engineering

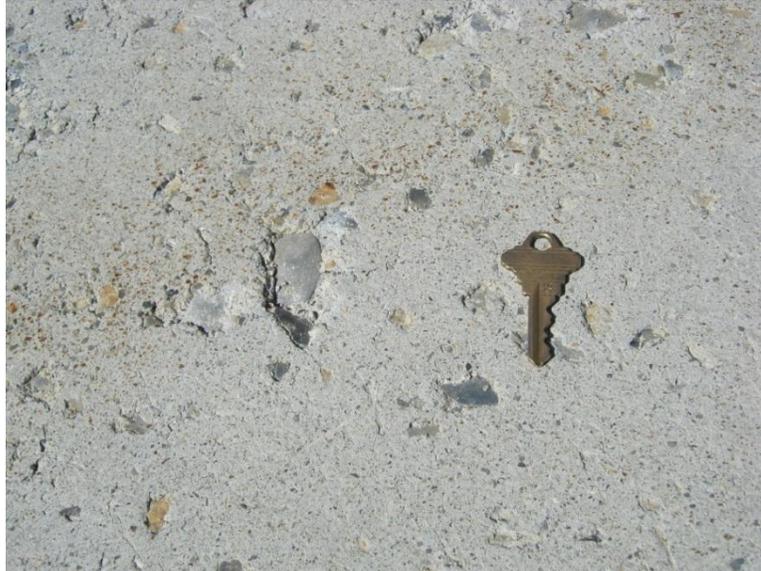
**Figure 2-1 Salt scaling.**

Most concrete deterioration induced by deicers is principally a result of physical processes. This damage is typically manifested in cracking and salt scaling, as shown in Figure 2-1. Scaling by itself will not incapacitate a concrete pavement, but it leads to greater concrete saturation and ingress of aggressive chemicals that may be present in the environment, making the concrete more susceptible to frost action and chemical attack. Several mechanisms have been proposed to explain the phenomenon of salt scaling, including thermal shock, precipitation and growth of salt crystals, osmotic pressure, and glue spalling.

Thermal shock occurs in the concrete when deicers are applied to the concrete surface. When deicers are applied to ice, the melting point of the ice is reduced. If the melting point is reduced to a temperature lower than the temperature of the ice, the ice begins to melt. The requisite energy for melting is drawn from the concrete surface, which causes rapid cooling of the concrete surface. A temperature gradient is quickly formed that results in differential strain within the concrete. The concrete surface then experiences tensile stress (5), which may cause small cracks in the concrete that result in scaling of the concrete surface.

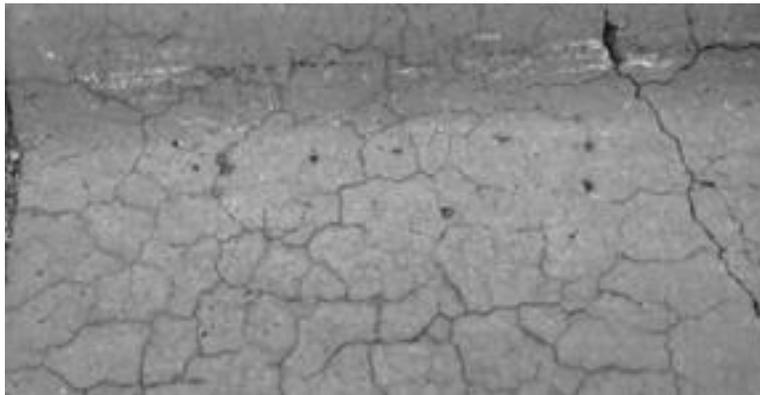
**Figure 2-2 Map cracking caused by ASR (3).**

ASR occurs in concrete produced with aggregate containing reactive silica. While opal and chert are common forms of reactive silica, other forms of silica have been found to be reactive to a lesser degree. Alkalis and calcium ions from cement present in the pore solution penetrate into reactive aggregate and form a non-swelling calcium alkali silicate hydrate (C-N(K)-S-H) gel, which behaves much like C-S-H, on the surface of the aggregate. The C-N(K)-S-H gel is relatively porous and allows additional alkalis and calcium ions to diffuse into the

aggregate. If the concentration of alkalis is high enough, an alkali silicate hydrate (N(K)-S-H) gel forms because the solubility of CH, the source of calcium ions, is inversely proportional to the alkali concentration. The N(K)-S-H gel diffuses away from the aggregate, where it swells as it attracts water through osmosis. Swelling of the N(K)-S-H gel subsequently produces tensile stresses in the concrete and eventually causes map cracking, as shown in Figure 2-2. As the silica reacts with the penetrating ions, the aggregates become susceptible to further penetration and subsequent reaction (39), and the reaction then occurs at varying speeds depending on the reactivity of the silica, the availability of alkalis, and the amount of moisture present. It has caused concrete failures in time periods ranging from 1 to 50 years (3).

Many researchers have found that deicing salts accelerate ASR in concrete containing reactive aggregate (40, 41, 42, 43, 44, 45). The reaction can be accelerated by any deicer that provides additional alkalis to react with the silica (46). The surplus of alkalis in the pore solution lowers the CH solubility, which increases the formation of swelling N(K)-S-H gel. Researchers have also found that chloride ions from deicing salts can play a role in accelerating ASR (47, 48).

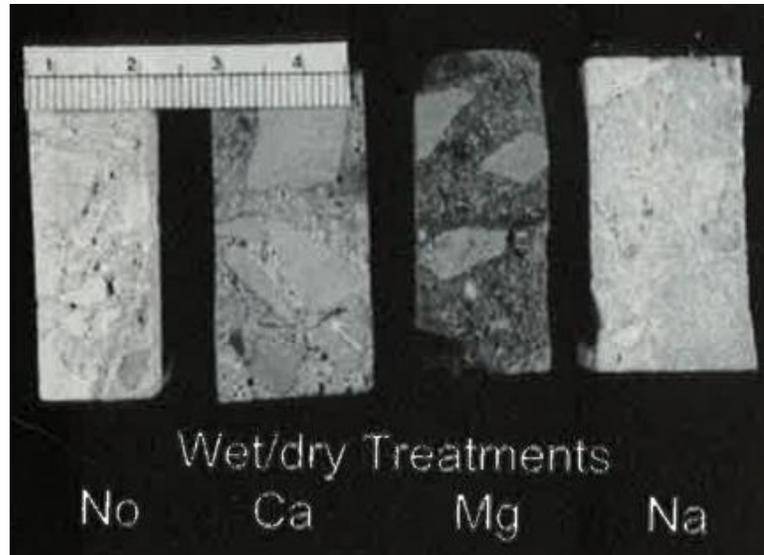
**Figure 3-1 Results of wet-dry experiment conducted by Cody et al. (30).**

In the wet-dry experiments, concrete blocks were immersed in 140°F (60°C) solutions for 132 hours, followed by a drying period of 24 hours at 140°F (60°C). The specimens were then air cooled to 77°F (25°C), immersed in 77°F (25°C) solutions, and heated in those solutions to 140°F (60°C) to begin another cycle. The high temperatures were chosen to simulate conditions experienced by concrete pavements during hot and dry summers. The short cycling time was used to accelerate test results. Cycling was performed until additional deterioration would prevent petrographic examination of the specimens.

In each of their experiments, the researchers found that calcium chloride and magnesium chloride solutions damaged the concrete measurably, while sodium chloride solutions had only minor effects on the concrete as shown in Figure 3-1. They also found that the effects of magnesium acetate and magnesium nitrate solutions were similar to those of magnesium chloride, suggesting that solutions containing magnesium deteriorate concrete similarly, regardless of the accompanying anion.

The researchers found that M-S-H conversion, as well as brucite formation, led to the deterioration of the magnesium chloride-soaked specimens. They also concluded that formation of complex salts may have been the cause of deterioration in the calcium chloride-soaked specimens. While recognizing that physical effects can accentuate the chemical effects of deicer solutions on concrete, the researchers concluded that chemical effects were the primary cause of the concrete deterioration, even in specimens subjected to freeze-thaw cycling.

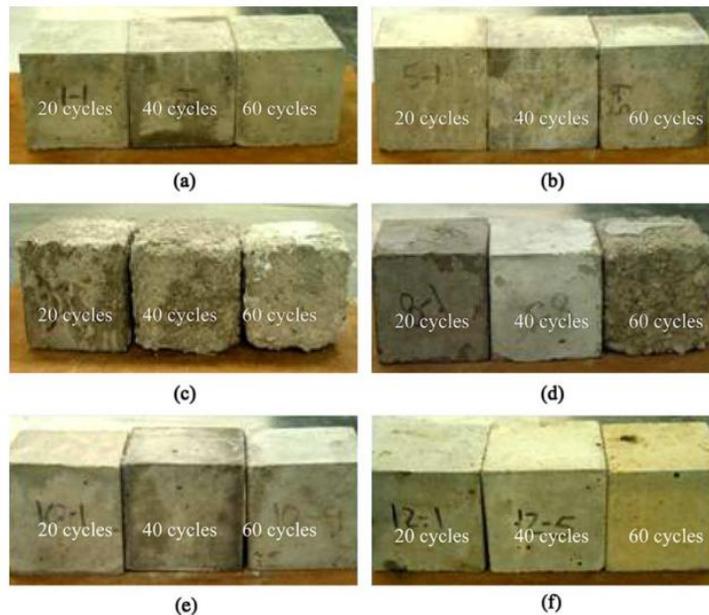
**Figure 3-2 Specimens exposed to deicers and freeze-thaw cycling: (a) H<sub>2</sub>O, (b) NaCl, (c) CaCl<sub>2</sub>, (d) CaCl<sub>2</sub> with corrosion inhibitor, (e) K acetate, (f) agricultural deicing product (19).**

The researchers found that the calcium chloride solutions, both with and without corrosion inhibitor, caused the most damage to the concrete and paste specimens. The physical conditions of the concrete specimens following testing are shown in Figure 3-2. The specimens exposed to calcium chloride experienced significant mass and compressive strength loss. The damage was caused by the formation of complex salts, CH leaching, and physical stresses caused by the precipitation of salt within the concrete pores. The sodium chloride, potassium acetate, and agricultural deicing product did not cause significant strength or mass loss in the specimens exposed to them. Results were similar for both the paste and concrete specimens.

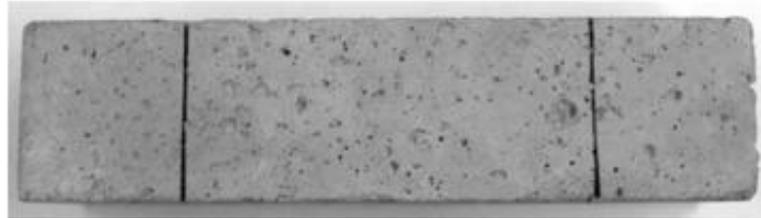
**Figure 3-3 Specimen following 95 weeks of exposure to distilled water (56).**

However, they did suffer some minor scaling. The specimens following testing are shown along with a specimen placed in distilled water for 95 weeks in Figures 3-3 to 3-7.

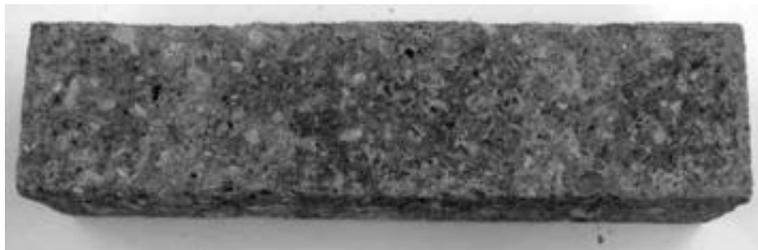
**Figure 3-4 Specimen following 95 weeks of exposure to 6.04 molal ion concentration of NaCl (56).**

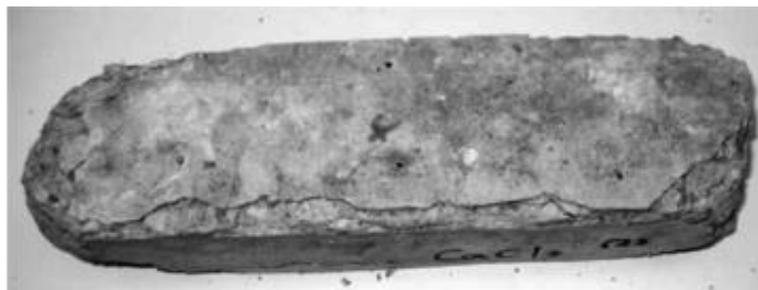
**Figure 3-5 Specimen following 10 weeks of exposure to 6.04 molal ion concentration of CaCl<sub>2</sub> (56).**

The researchers found that the specimens exposed to the high-concentration solutions of calcium chloride and magnesium chloride rapidly deteriorated. The dynamic modulus for these specimens decreased below 0.9 within 10 weeks of testing. The high-concentration CMA solution also deteriorated the concrete specimens. The  $P_{w/d}$  of these specimens decreased to 0.9 by the 55<sup>th</sup> week of testing. Each of the specimens subjected to calcium chloride, magnesium chloride, or CMA suffered significant scaling. Only the specimens exposed to sodium chloride endured the full 95 weeks of testing without experiencing a decrease of  $P_{w/d}$  below 0.9.

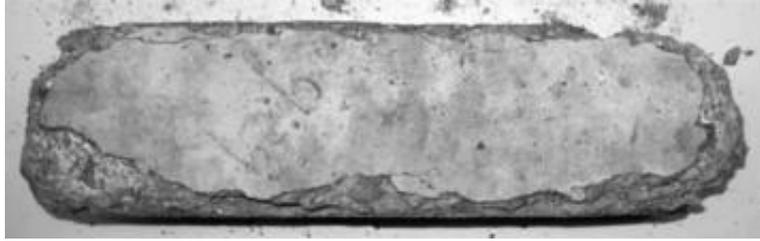
**Figure 3-6 Specimen following 10 weeks of exposure to 6.04 molal ion concentration solution of  $\text{MgCl}_2$  (56).**

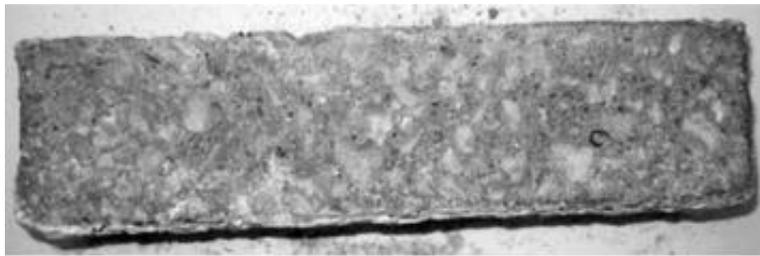
**Figure 3-7 Specimen following 60 weeks of exposure to 6.04 molal ion concentration of CMA (56).**

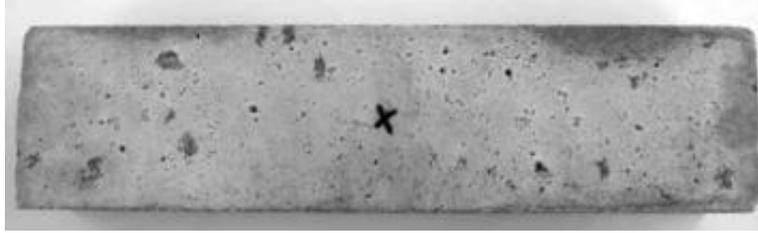
**Figure 3-8 Specimen following 95 weeks of exposure to 1.06 molal ion concentration solution of NaCl (56).**

The specimens exposed to the low-concentration solutions deteriorated more slowly. The magnesium chloride and CMA-exposed specimens decreased to a  $P_{w/d}$  of 0.9 after 80 and 95 weeks of exposure, respectively. The specimens exposed to calcium chloride and sodium chloride endured the full 95 weeks. The specimens following testing are shown in Figures 3-8 to 3-11. The researchers did not identify the deterioration mechanisms that led to the deterioration of the concrete specimens in the various solutions.

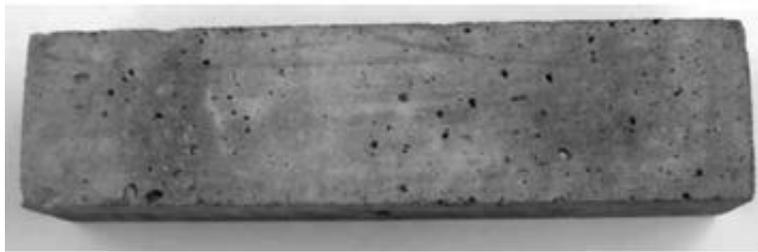
**Figure 3-9 Specimen following 95 weeks of exposure to 1.06 molal ion concentration solution of CaCl<sub>2</sub> (56).**

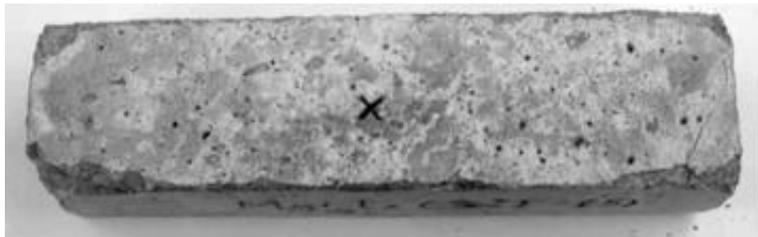
**Figure 3-10 Specimen following 80 weeks of exposure to 1.06 molal ion concentration solution of MgCl<sub>2</sub> (56).**

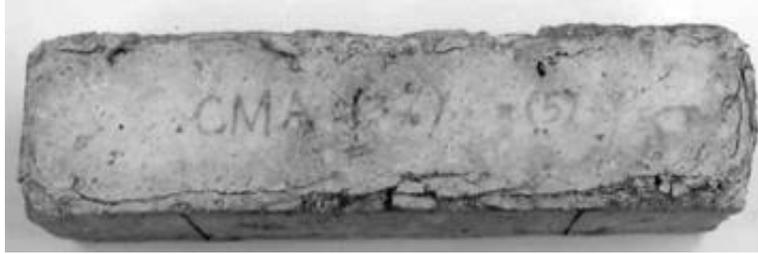
**Figure 3-11 Specimen following 95 weeks of exposure to 1.06 molal ion concentration solution of CMA (56).**
